**NASA
Technical
Memorandum**

NASA TM - 100361

**A NONCONTACTING SCANNING PHOTOELECTRON
EMISSION TECHNIQUE FOR BONDING SURFACE
CLEANLINESS INSPECTION**

Materials and Processes Laboratory
Science and Engineering Directorate

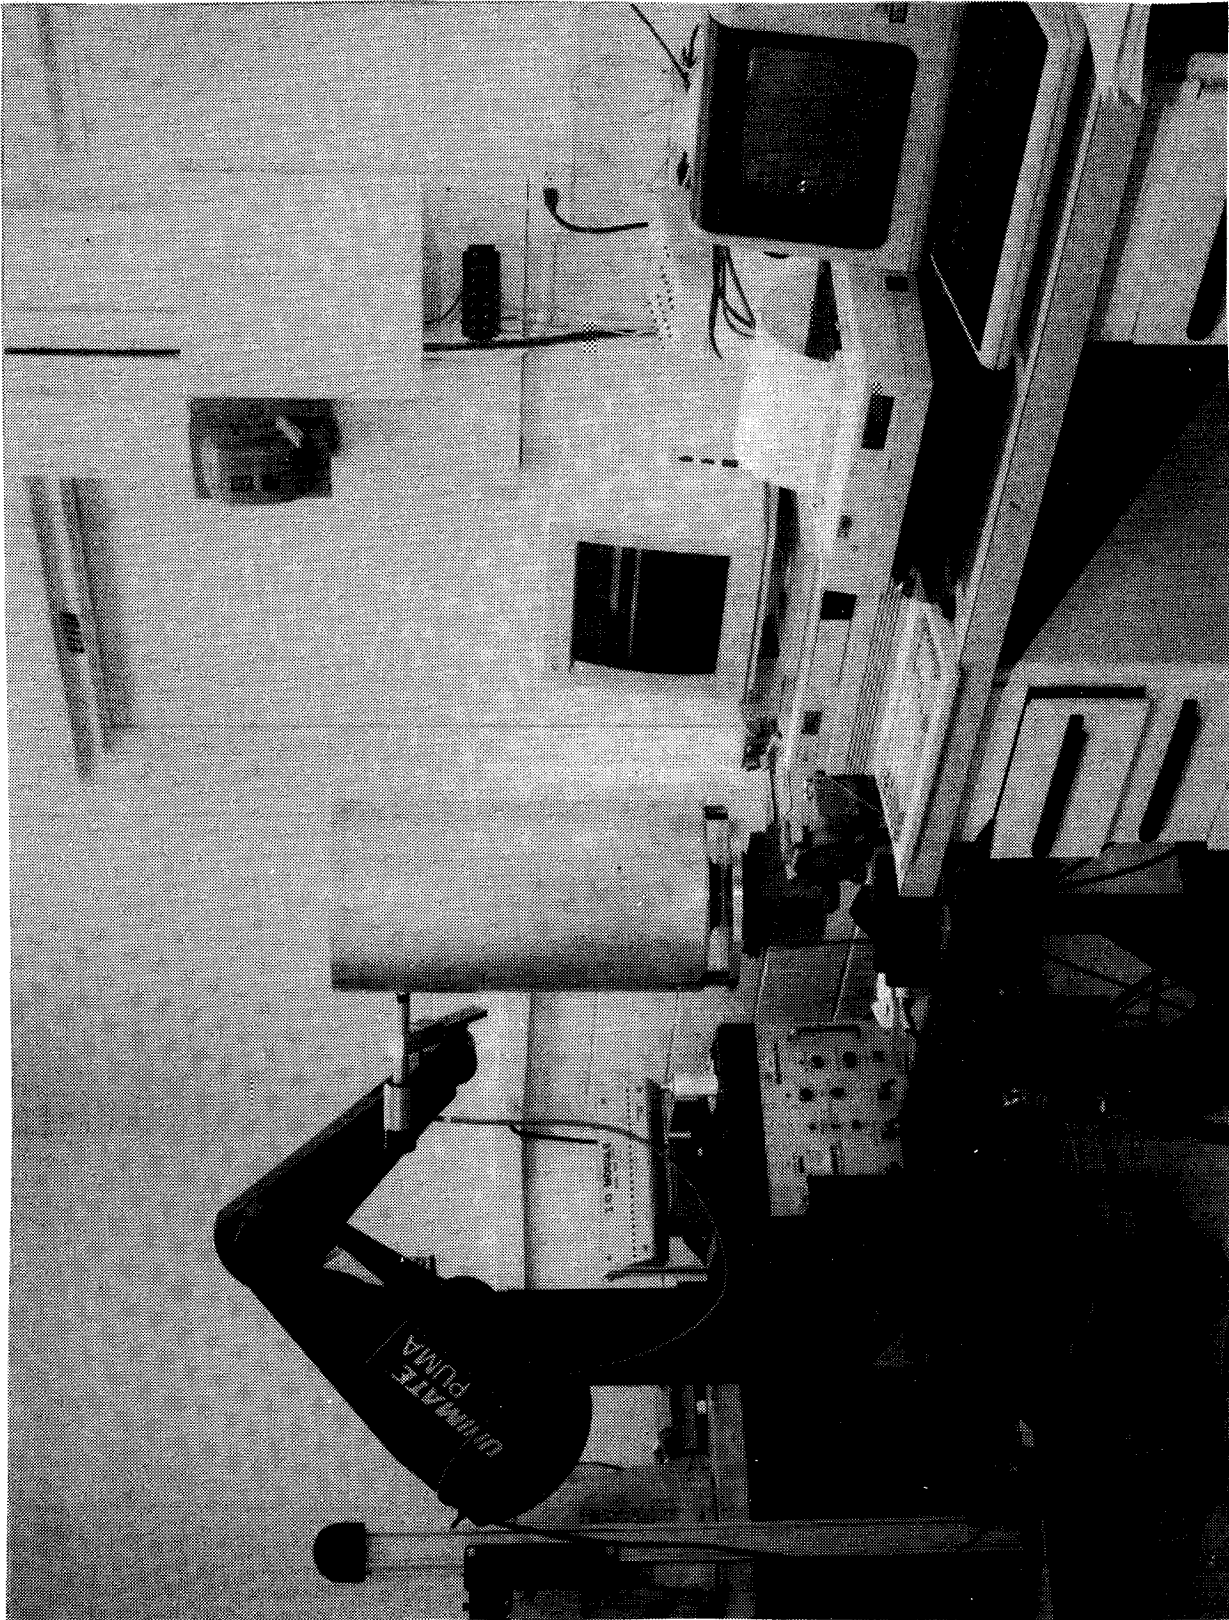
Figure 37. OSEE scanning of BSM.

Figure 37 shows the development setup for scanning of the BSM Case which is 7075-T73 aluminum. The ConScan system described earlier is being used for this application. Representative scans of the BSM Case are shown in Figures 38 and 39. The first scan shows the case prior to cleaning. The second scan shows the effect of sanding thoroughly. The dark spots are very thin layer contaminants (release agent, top and hydraulic oil, bottom) that were applied on the otherwise clean area.
